PHOTOGRAPHIC INTELLIGENCE REPORT

CHERNOVTSY ARMY BARRACKS
ROSHTSHINSKAYA AL 2, USSR
(CARPATHIAN MILITARY DISTRICT)

CIA/PIR 67061

DATE September 1965
COPY 17
PAGES 5

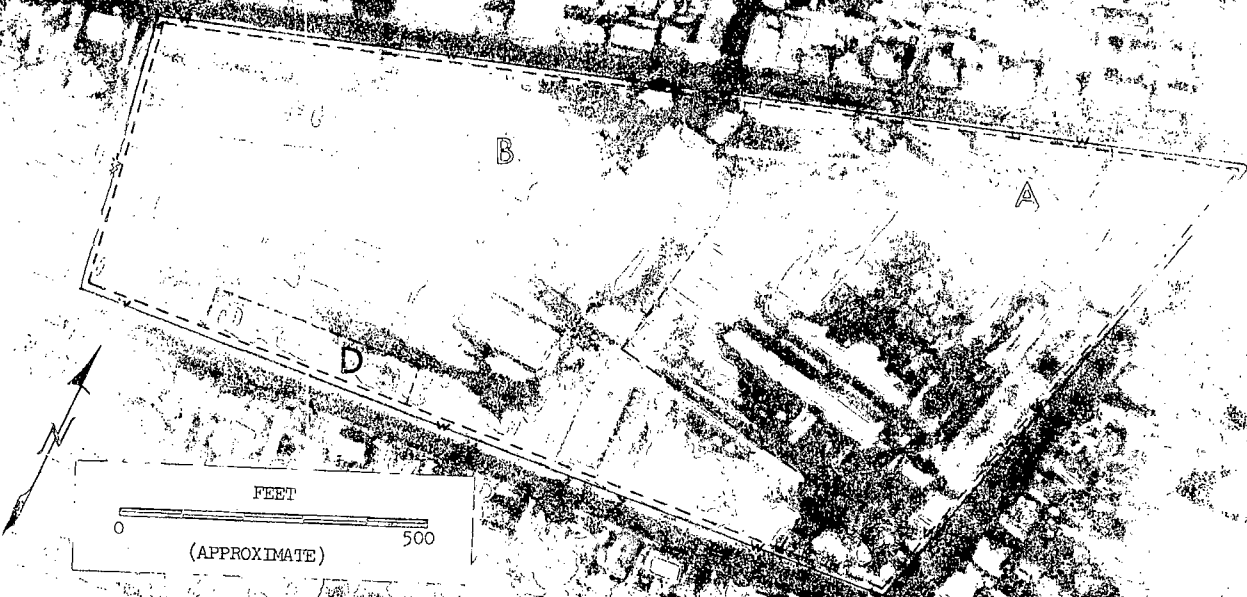
FIGURE 1

- A. 1 Multistory barracks
2 Barracks
1 Barracks/administration building
8 Support buildings
- B. 1 Vehicle/equipment storage building
2 Vehicle/equipment storage buildings
2 Vehicle/equipment storage buildings
1 Probable maintenance building (monitor roof)
1 Building under construction
3 Support buildings
- D. 2 Revetted explosives storage buildings

Three possible trucks are located by the probable maintenance building.

The only snow observed on roofs is on the north side of three of the storage buildings. Heavy vehicular scarring is observed in the motor pool area with distinct scarring observed on both sides of the east vehicle/equipment storage shed. The barracks area has all sidewalks and foot paths cleared of snow.

The installation is covered on clear, fair quality photography. No security measures separating the barracks area from the motor pool can be observed.
