STUDIES in INTELLIGENCE

THE KIDNAPING OF THE LUNIK

Sydney Wesley Finer

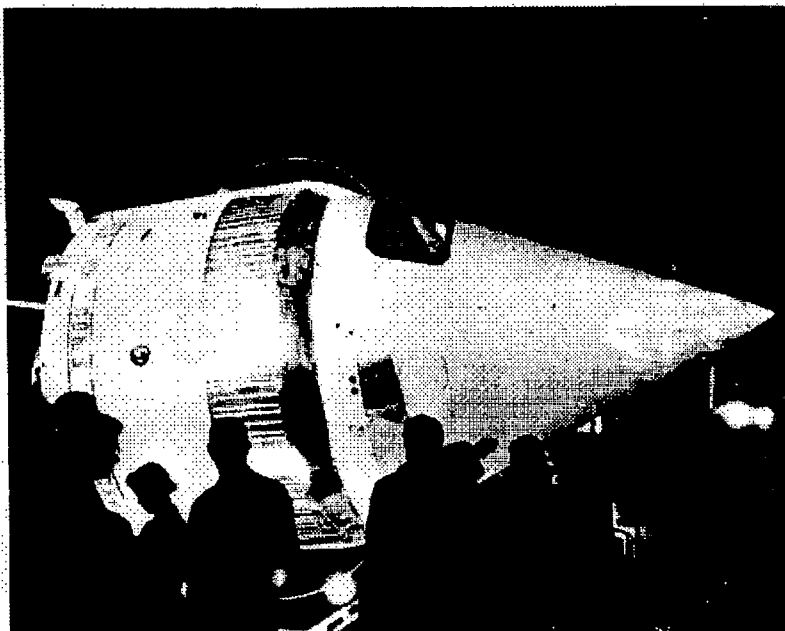
The Lunik

found that it was indeed a production item from which the engine and most electrical and electronic components had been removed. They examined it thoroughly from the viewpoint of probable performance, taking measurements, determining its structural characteristics and wiring format, estimating engine size, and so forth.¹

The late shipment turned out to be the last-stage Lunik space vehicle, lying on its side in a cabin-like crate approximately 20 feet long and 11 feet wide with a roof about 14 feet high at the peak. It was unpacked and placed on a pedestal. It had been freshly painted, and three inspection windows cut in the nose section permitted a view of the payload instrument package with its antenna. It was presumably a mock-up made especially for the exhibition; the Soviets would not be so foolish as to expose a real production item of such advanced equipment to the prying eyes of imperialist intelligence.
